V-11 LAND CORNER RECORD

RECORD OF LAND CORNER MONUMENTATION

NORTH 1/4 CORNER SECTION 33, T. 6 S., R. 42 E., W.M.

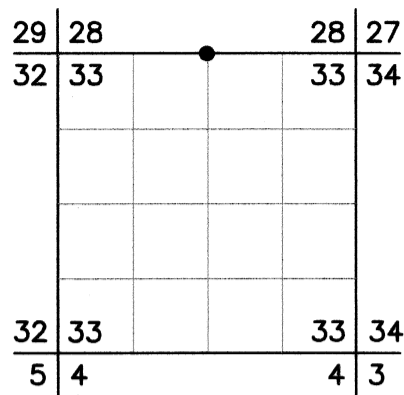
EVIDENCE FOUND: I found the remains of the original northeast bearing tree, which is a sawn Douglas-fir stump, approximately 40 inches in diameter and 1.5 feet tall. At a point 6 inches out from the pith, I removed the outer wood to reveal the pitched-over lower blaze and scribing "BT" visible. There is no trace of the corner stone or the southwest bearing tree, as both fall within the prism of an irrigation ditch and have been destroyed. I reestablish the 1/4 corner at G.L.O. record bearing and distance from the found remains of the bearing tree.

The corner point falls in the irrigation ditch, where it is impracticable to set a monument. Therefore, I establish a witness corner East, 25.00 feet from the true corner position, where I set a standard USFS 2½"x30" aluminum pipe with attached 3¼" aluminum cap, 29" in the ground. Raised a 2 ft. diameter mound of stone around the monument to top of cap. Cap is marked as shown below.
