Appendix E
Landslide Inventory

APPENDIX E - LANDSLIDE INVENTORY

This appendix presents summary information and site maps of each landslide that was identified along the IPC Proposed Route, IPC Alternate and NEPA Alternate route alignments, and certain other landslides within 1-mile-wide alignment corridors that could potentially affect the stability of tower foundations. The majority of the transmission line routes were reviewed, and landslides compiled by Shaw Environmental & Infrastructure, Inc. (Shaw), and the findings of their research were first presented in their Desktop Geotechnical Report, dated January 19, 2012. Landslides along subsequent new alignments, such as the IPC Willow Creek Alternate and the NEPA Flagstaff Alternate, as well as changes to the previous alignments, were compiled by Shannon & Wilson, Inc. (S&W). Data for the new alignments and changes to the previous alignments are integrated with the IPC Proposed Route in this appendix. The landslide inventory was compiled from the following data sources:

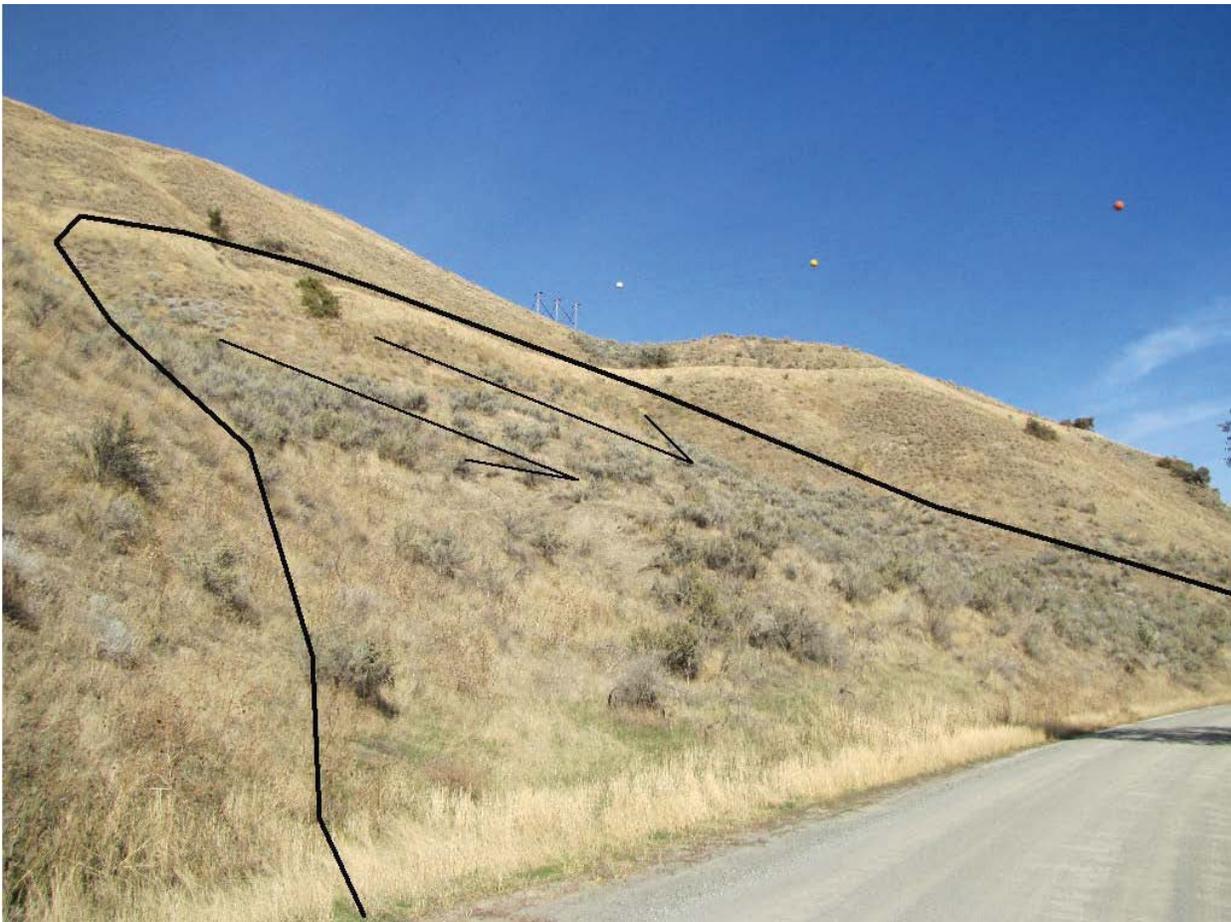
PLS-011 is a small (1.7-acre) potential landslide that was identified in the field based on geomorphology characteristic of a landslide. No evidence of recent movement was observed. The nearest proposed tower location (848) is 500 feet uphill of this small potential landslide and the tower would not be affected by it.

Photo 1: Toe of PLS-011 looking northeast from Dixie Creek Road

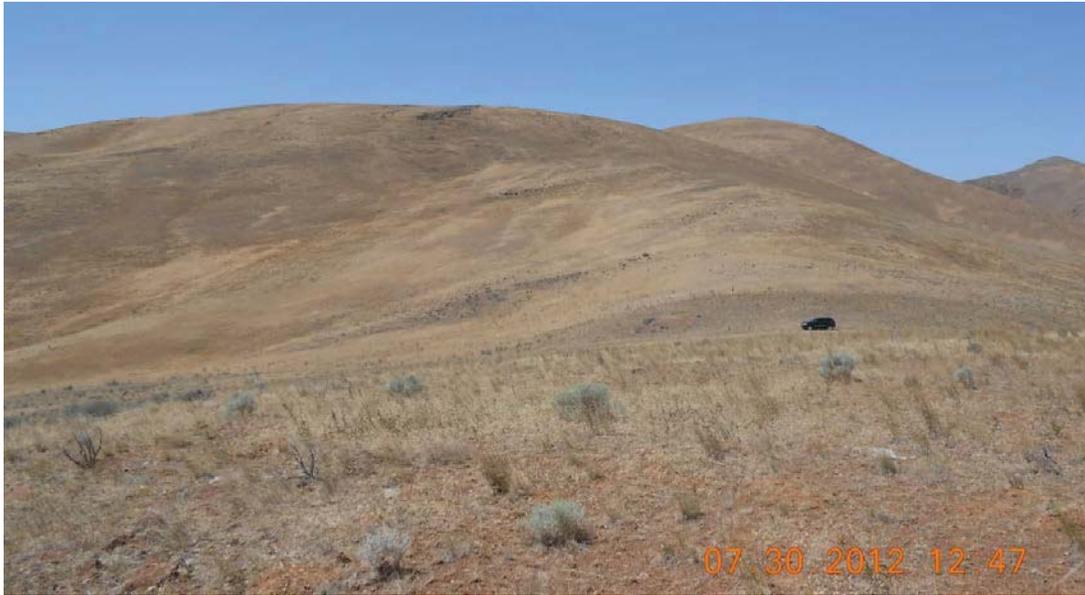
The feature designated PLS-012 is not identified as a landslide in SLIDO or on published geologic maps. During field reconnaissance, however, some observations were made that suggest PLS-012 is a possible landslide. These observations included uneven topography (Photo 1), mixed lithology in the float material, and an arcing depression near the top of the feature. The nearest proposed tower locations, towers 7 and 8, are approximately 200 feet away from apparent extents of the PLS-012 feature; and while debris from PLS-012 would likely head toward the location of tower 8, it does not appear likely that the material would remobilize in a mass failure. In our opinion, risks posed to the proposed alignment by PLS-012 are low.

Photo 2: Looking west at PLS-012 and approximate location of tower 7 (7/30/2012)

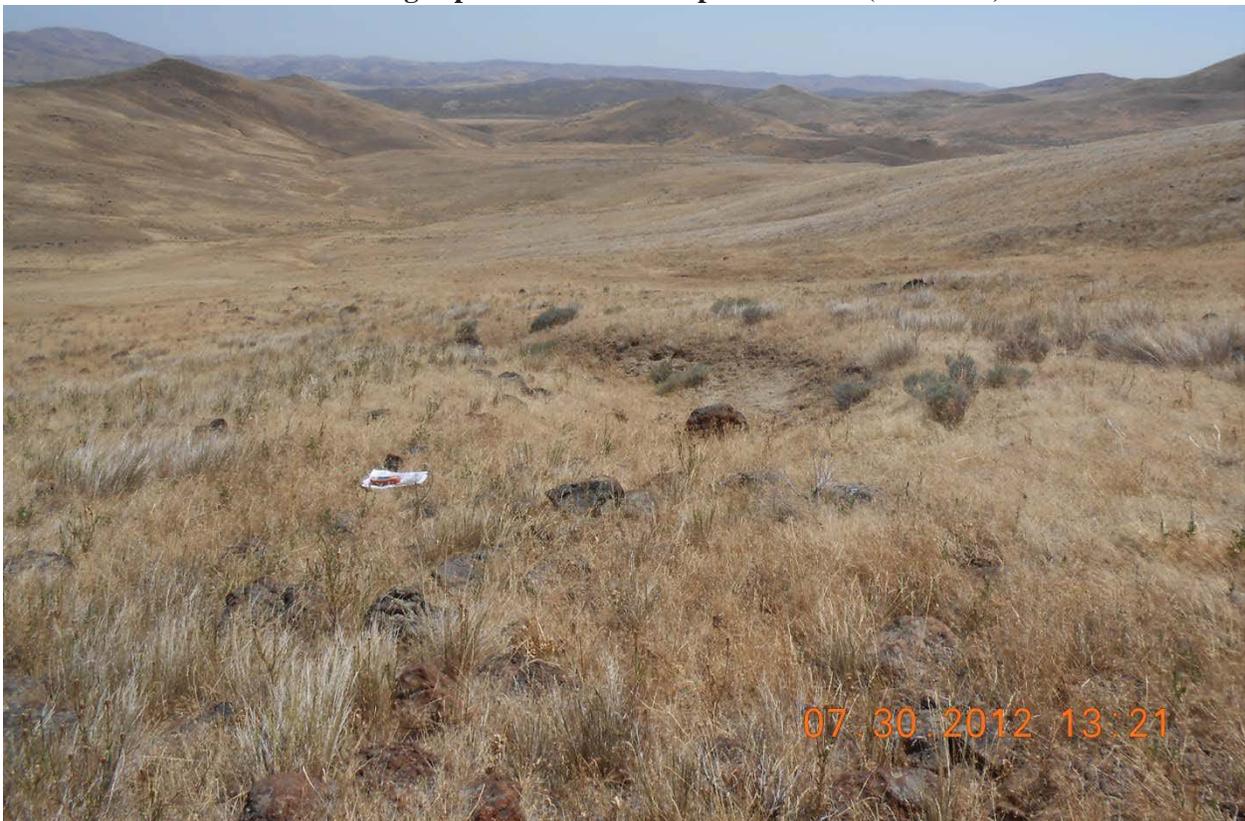
Photo 3: Arcing depression near the top of PLS-012 (7/30/2012)

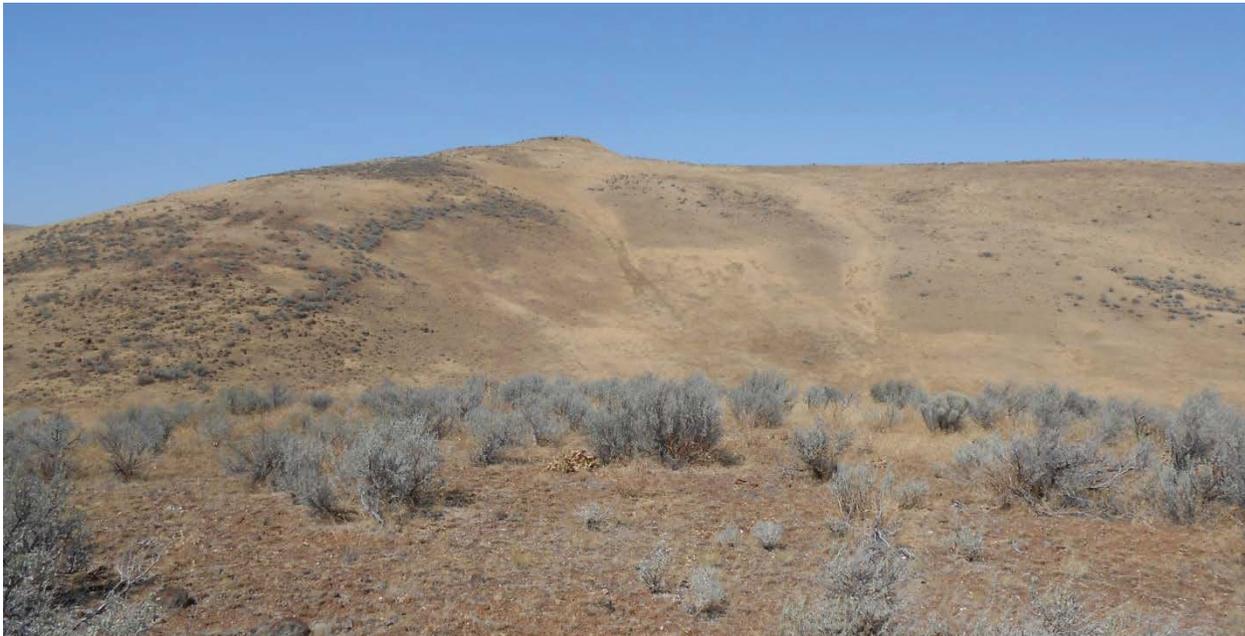
The feature designated PLS-013 is not identified as a landslide in SLIDO or on published geologic maps. However, during review of aerial photos and field reconnaissance, we observed characteristics consistent with a possible rock slide. The feature is more than 500 feet from the closest proposed tower locations, towers 13 and 14, and feeds into a drainage well below and away from either tower. In our opinion, PLS-013 does not pose a risk to the proposed alignment, though it should be avoided or minimally disturbed during access road construction.

Photo 4: Looking north, across a drainage, at PLS-013 from the approximate location of Tower-14 (7/30/2012)

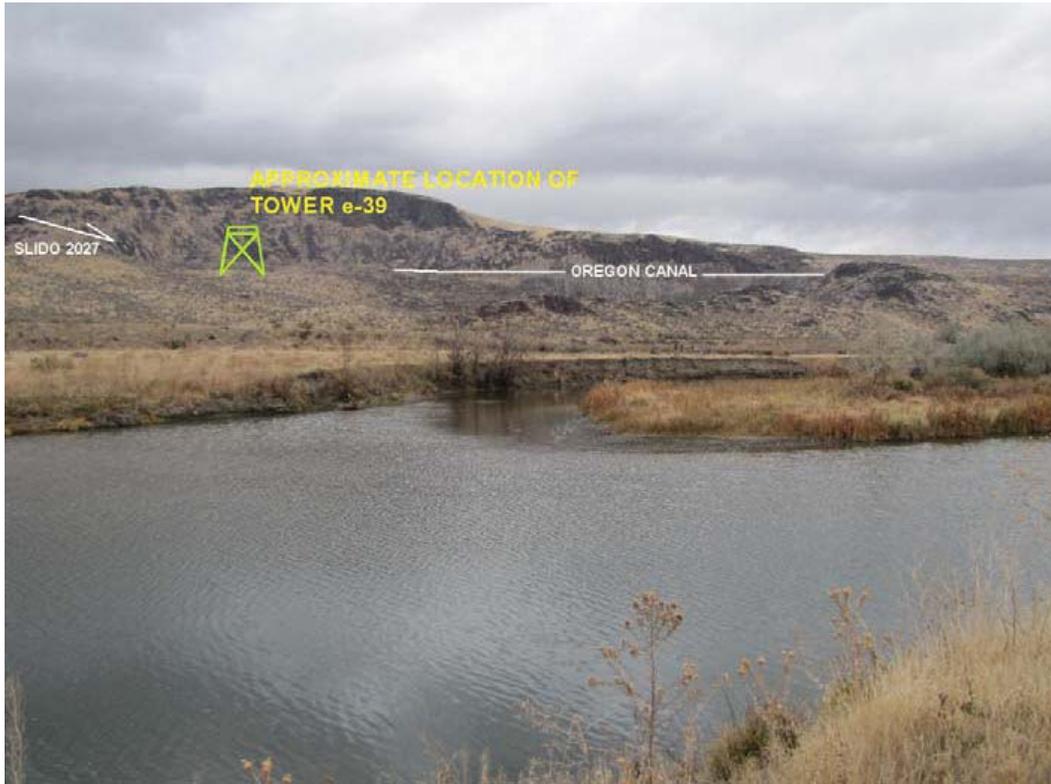
On November 17, 2011, a site visit of this landslide area was conducted by walking along the access road on the southeast side of the Malheur River from the eastern end of SLIDO 2030. Since the Oregon Canal is constructed on SLIDO 2027, these landslide deposits are very likely relatively stable. However, actual proposed tower locations should be inspected for stability during geotechnical exploration and tower construction.

Photo 5: Looking north towards tower 1042 (formerly tower e-29) and eastern flank of SLIDO 2027 (11/17/2011)

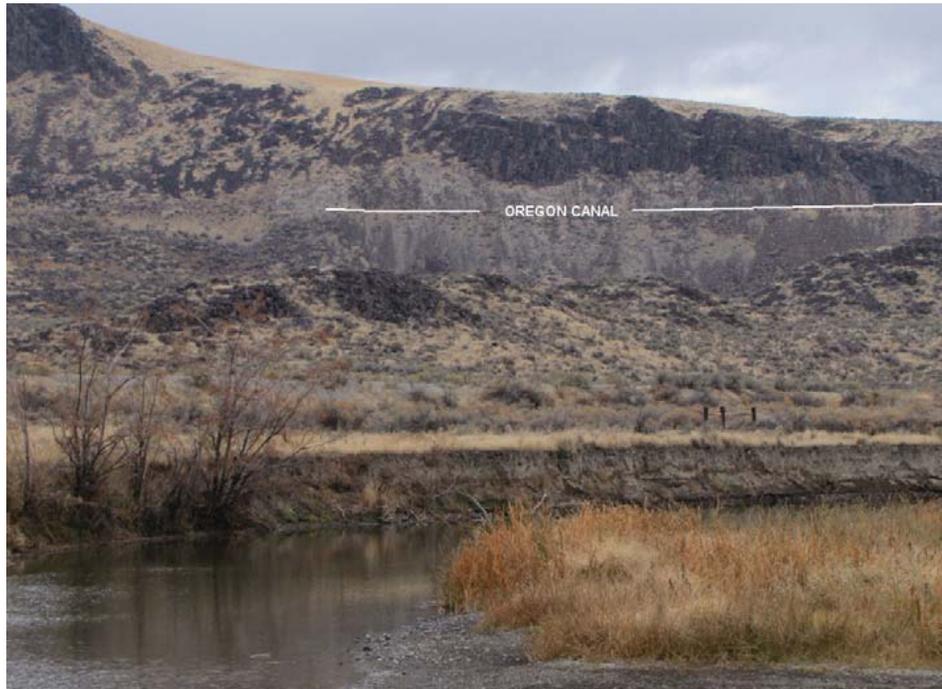
Photo 6: Looking north toward Oregon Canal and eastern flank of SLIDO 2027 (11/17/2011)

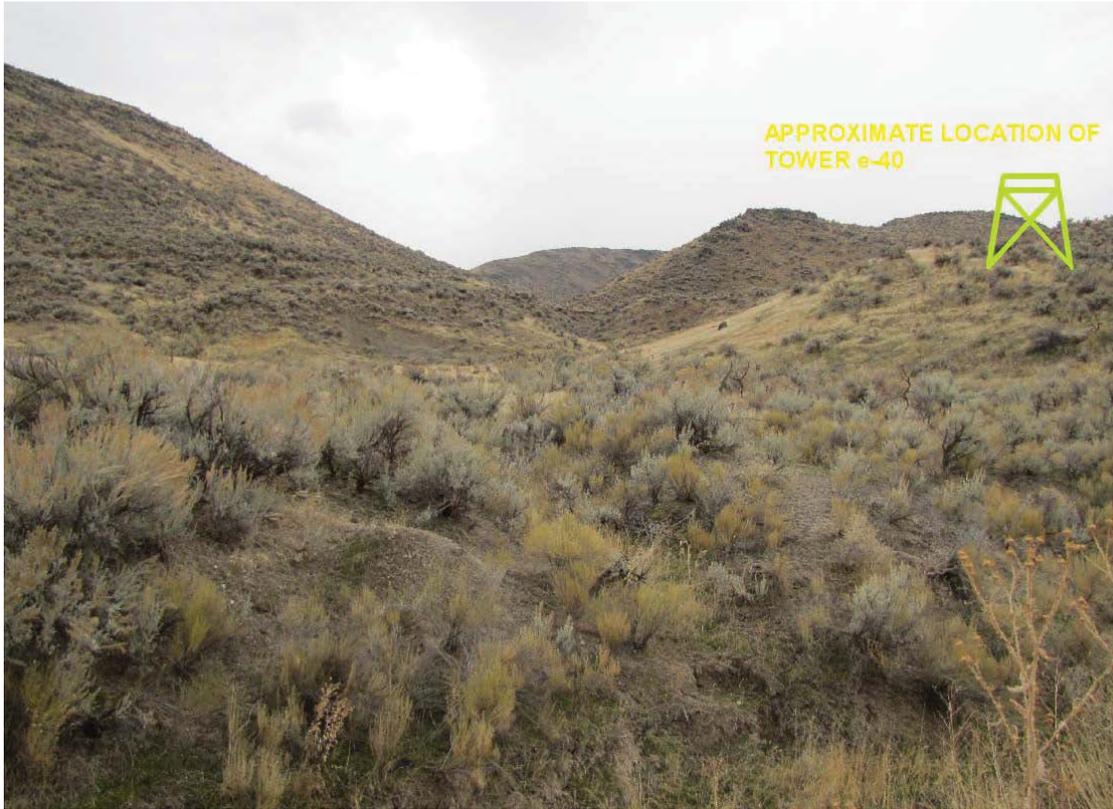
**Photo 7: Looking south towards tower 1043 (formerly tower e-40) and
SLIDO 2030 (11/17/2011)**

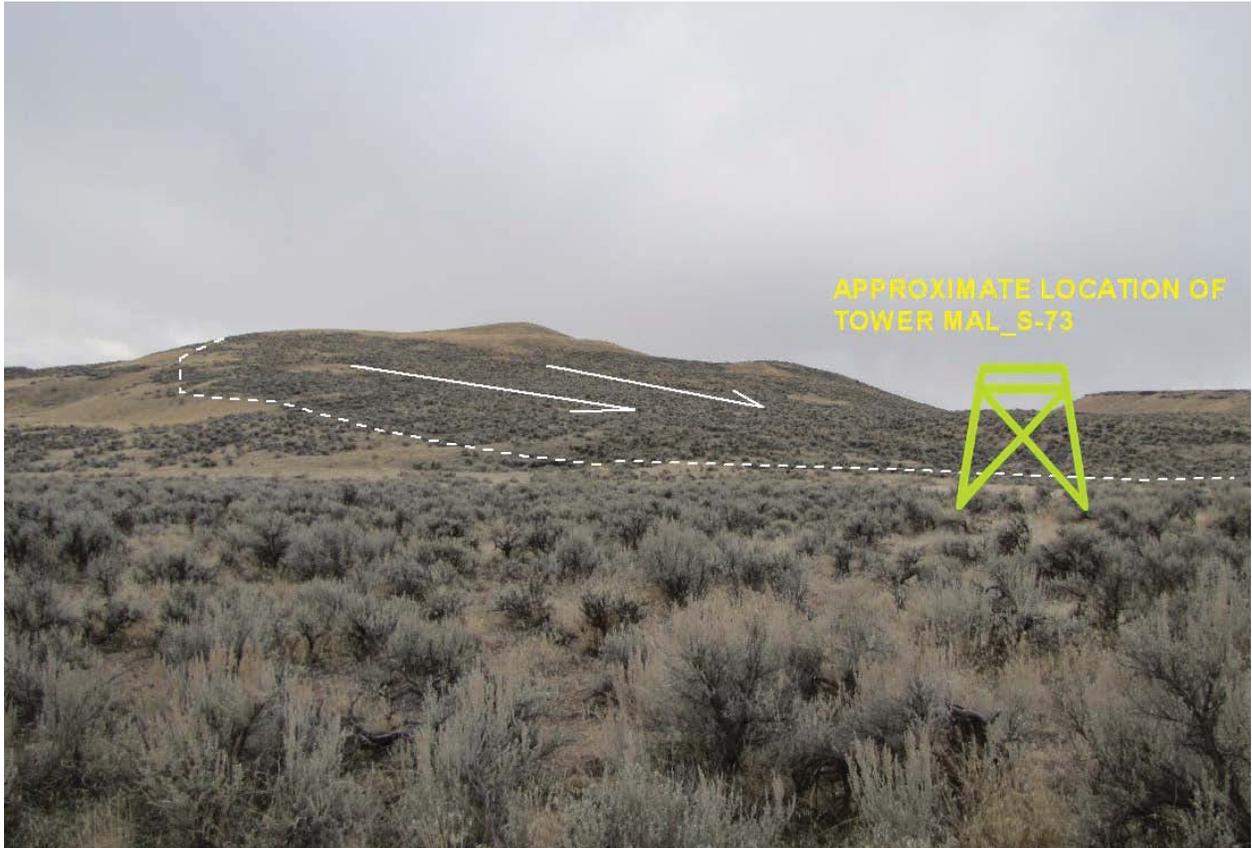
SLIDO 2039 is referenced at the scale of 1:100,000 (Ferns et al., 1993) as a 51-acre landslide. On November 17, 2011, a site visit of this landslide area was conducted. No evidence of recent movement was observed, and proposed tower location 59 appeared to be located on alluvium beyond the toe of the landslide.

Photo 8: Looking northwest towards tower 59 (formerly tower MAL_S-73) location and toe of SLIDO 2039 (11/17/2011)

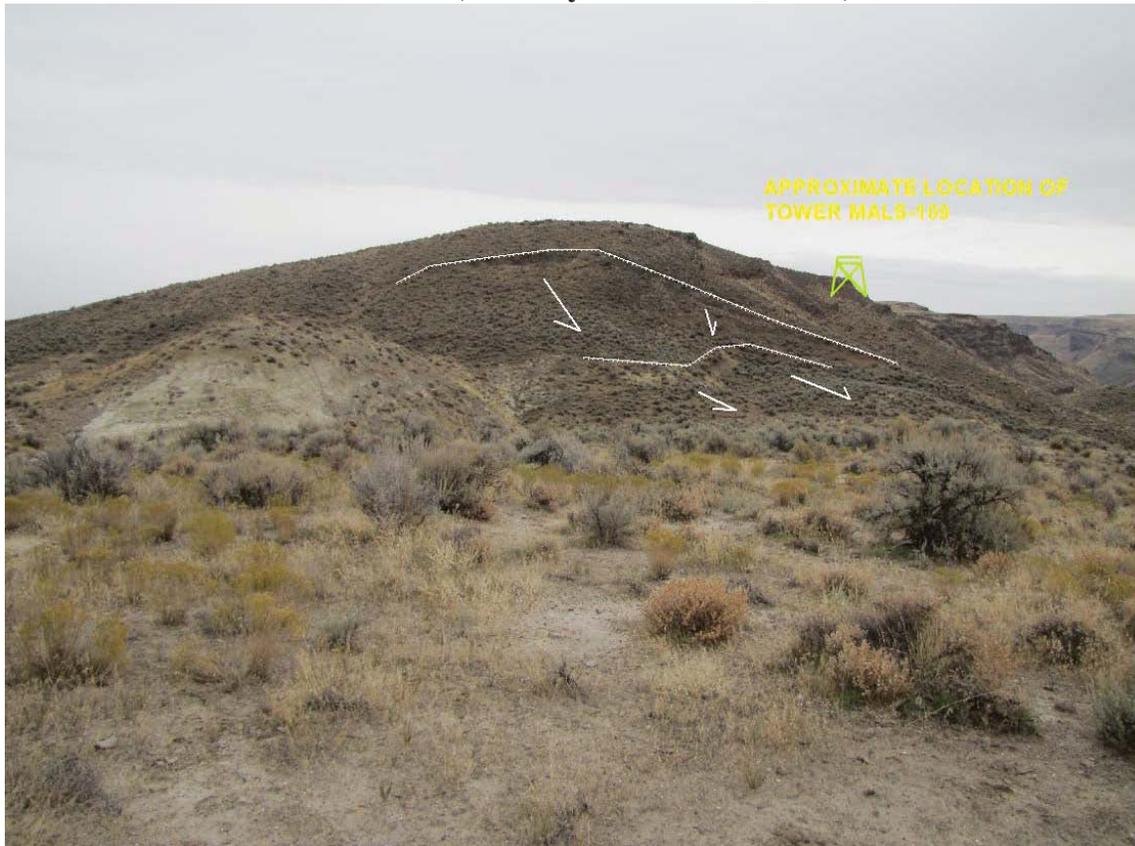
The northernmost of the 3 proposed route alternatives crosses the northern tip of the landslide between proposed towers 94 and 95. Fresh landslide scarps were observed and photographed 200 feet west of proposed tower 95 (See photos 1 and 2). However, in-place bedded Owyhee Basalt (Tbo) can be seen on the aerial photo at the proposed location of tower 95 (Ferns and Ramp, 1989).

Photo 9: Looking east at landslide scarps 200 feet west of tower 95 (formerly tower MAL_S-109)

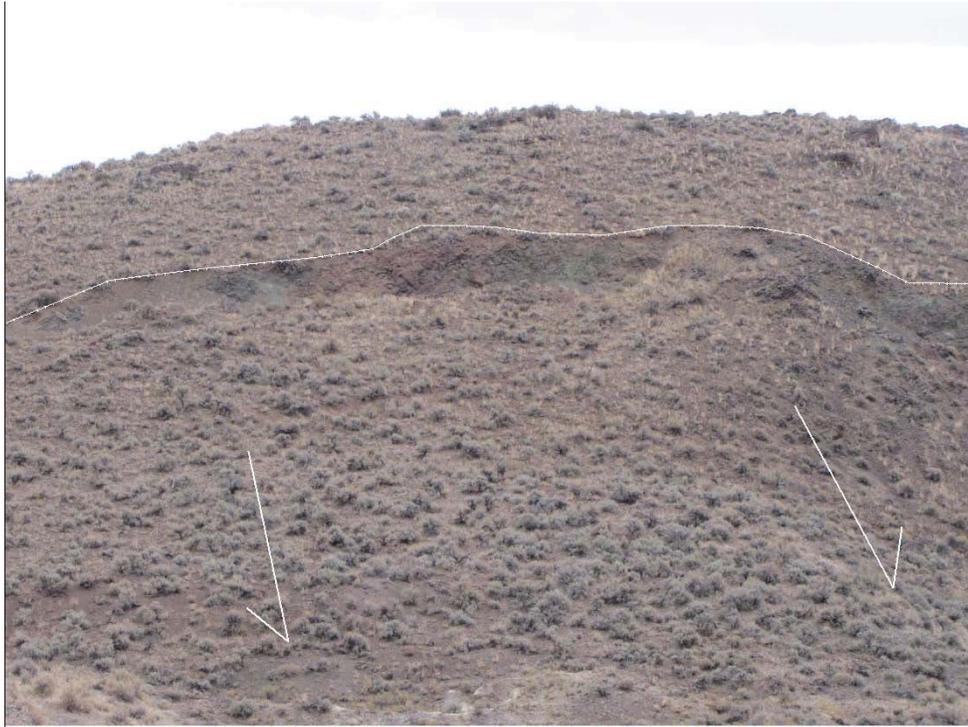
Photo 10: Head scarp 200 feet west of tower 95 (formerly tower MAL_S-109)

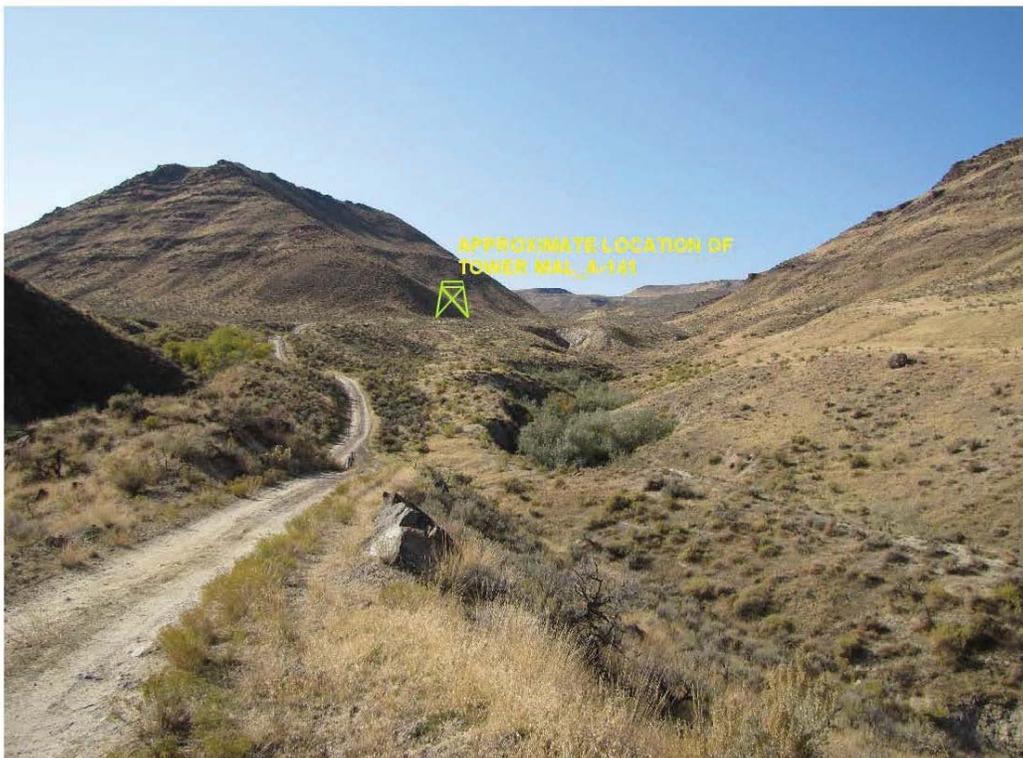
The southernmost proposed route alternative (NEPA Malheur A) is located along a debris flow deposit that runs west to east towards the Owyhee River (See photo 3).

Photo 11: Looking west at landslide deposits and the tower formerly identified as MAL-A-141.

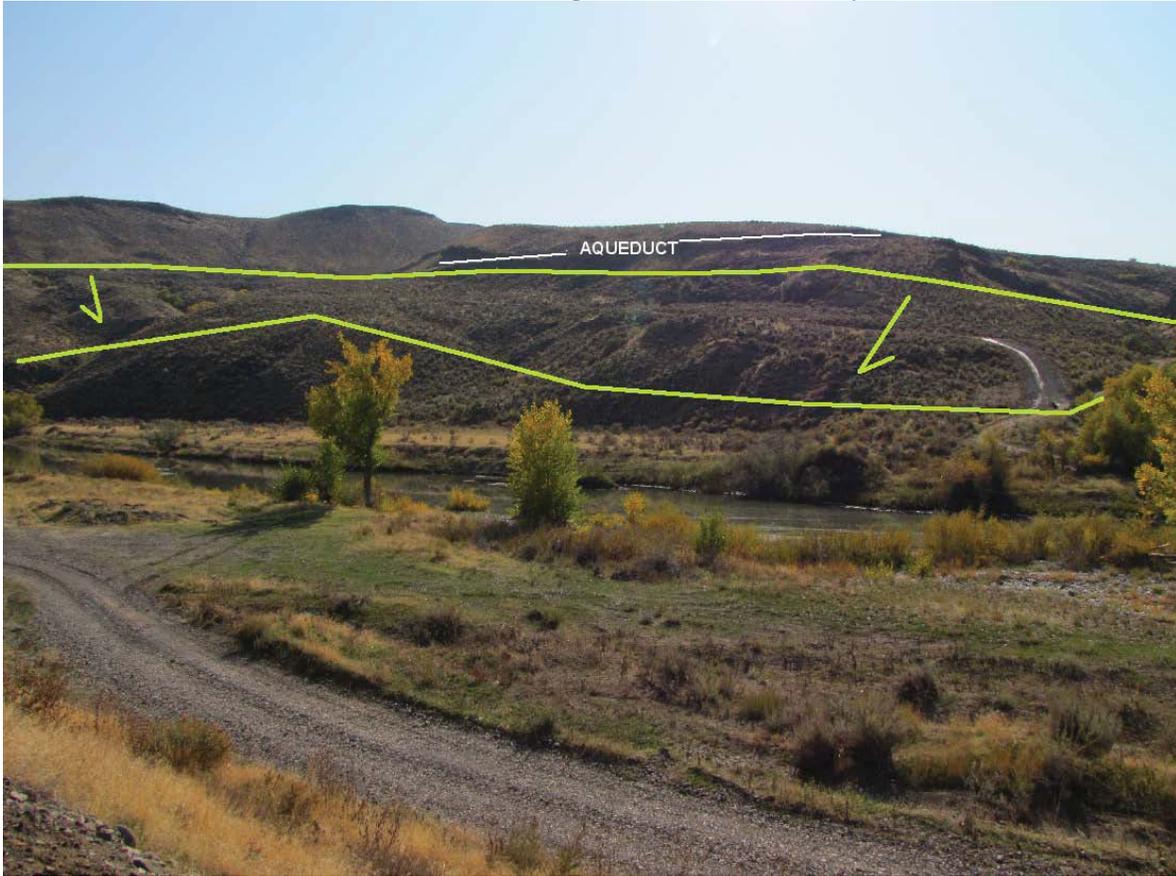
Photo 12: View of MLS-002 looking southeast from Owyhee River Road.
