CERTIFIED RECORD OF LAND CORNER MONUMENTATION

T 1 N R 38 E R-12

S	28

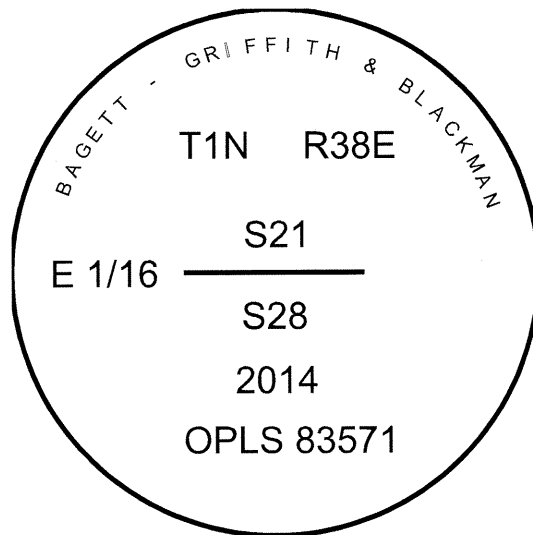
At a position determined by survey, I set a 5/8" x 30" iron pin with a 2 1/2" aluminum cap marked as shown 30" in the ground. From which:

A 5/8" x 30" iron pin with a 1 1/2" aluminum cap bears S 43° E, a distance of 25.17 feet, marked BGB SURVEY MARKER SE RP.

A 16" Western Larch bears S 14° W, a distance of 23.40 feet, marked E 1/16 S28 BT.

Set a steel fencepost +/- 0.5 foot South of corner monument.

I used a steel tape and magnetic compass in the establishment of the new accessory. I used 16° East declination, the distances are to a 60d spike driven into the right side of the root crown of the new bearing tree. A brass washer marked OPLS 83571 is attached to the BT blaze of the new bearing tree. I use a Leica GS15 RTK GPS in the establishment of the new iron pin accessory.
