**BASIS OF BEARINGS**

**SURVEY NARRATIVE**

THIS SURVEY WAS REQUESTED BY PHIL BURLING, OWNER OF THE W1/2 OF THE SE1/4 OF SEC. 32, T1N, R38E, FOR THE PURPOSE OF RE-ESTABLISHING THE SE CORNER OF HIS LAND WHICH HAD BEEN REMOVED DURING TIMBER HARVEST ACTIVITIES, AND FOR THE PURPOSE OF DETERMINING THE RELATIONSHIP OF THE EAST LINE OF THE W1/2 OF THE SE1/4 OF SEC. 32 TO THE EXISTING FENCE LOCATED ALONG THE NORTHERLY ONE-HALF OF SAID LINE.

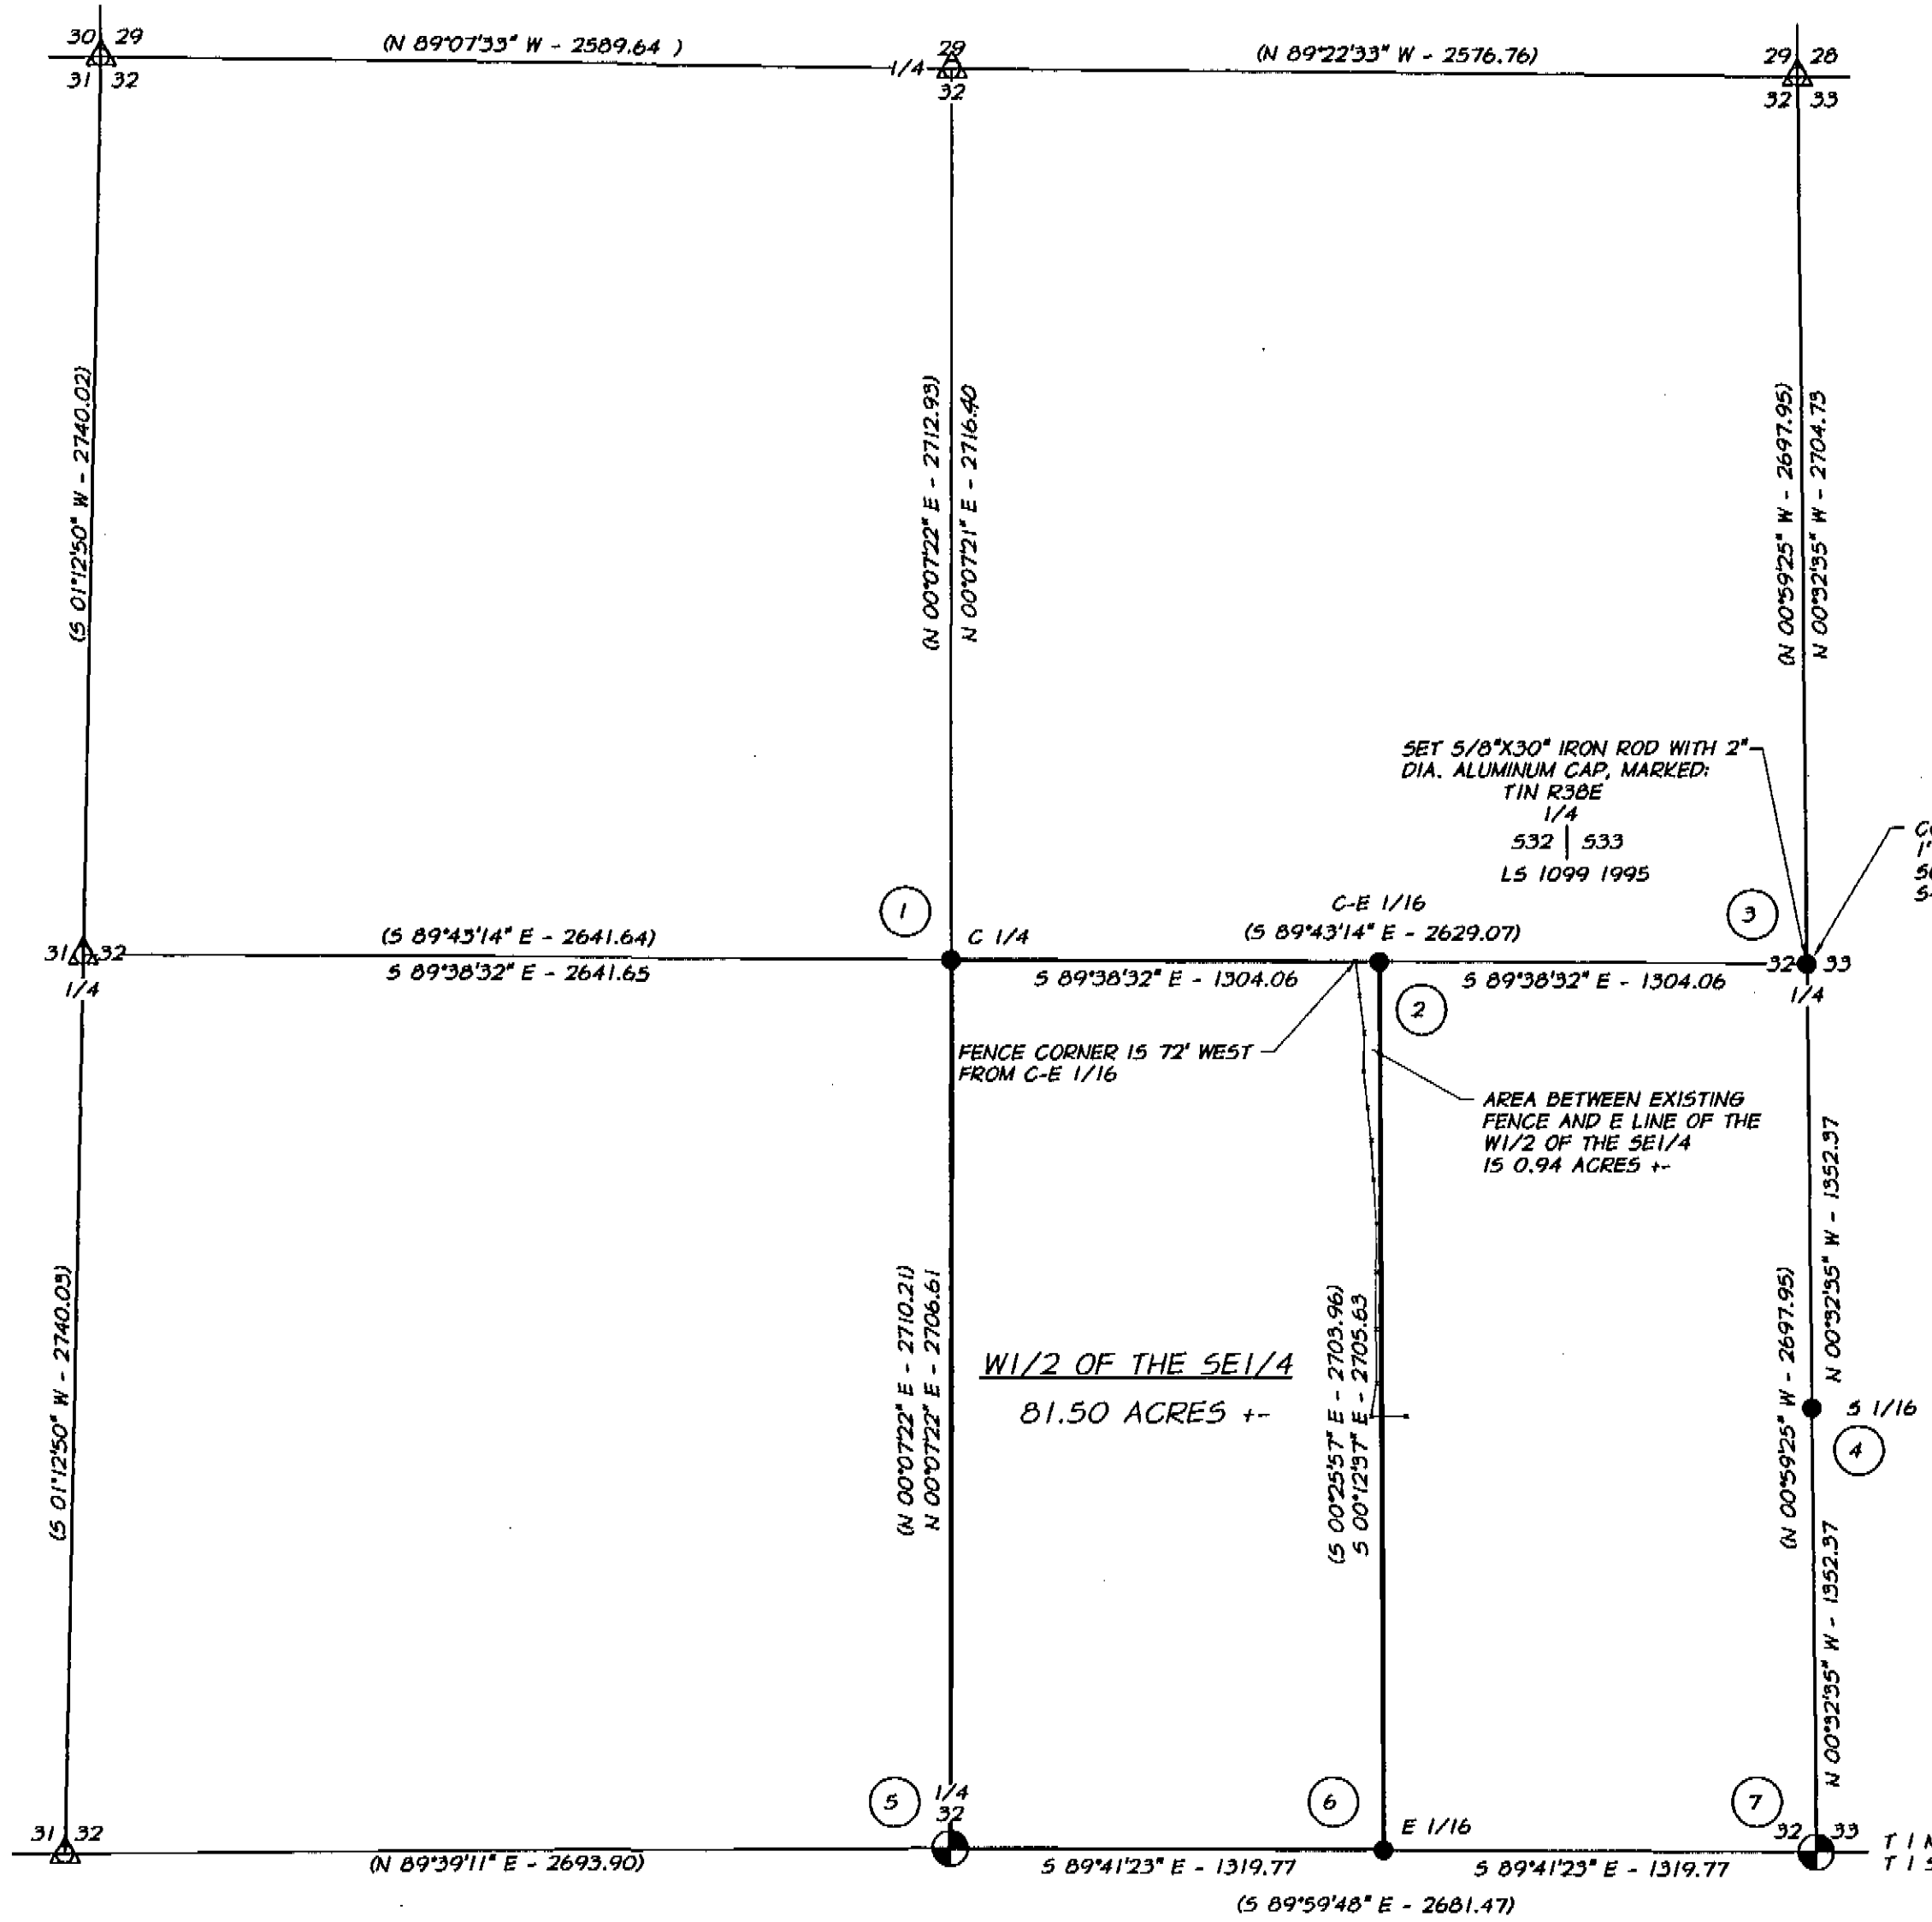
N 0° 59' 25" E BETWEEN THE SE CORNER OF SECTION 32 AND THE NE CORNER OF THE SE 1/4 OF THE SE 1/4 OF SECTION 32, T1N, R38E, AS SHOWN ON UNION COUNTY SURVEY NO. 38-80.

- FOUND MONUMENT AS DESCRIBED
- SET 5/8" X 30" IRON ROD (CONCRETE REINFORCING ROD) WITH YELLOW PLASTIC CAP ATTACHED, MARKED "AP1A", UNLESS OTHERWISE NOTED
- △ RECORD POSITION AS SHOWN ON UNION COUNTY SURVEY NO. 38-80, POSITION NOT VISITED DURING THIS CORRECTION SURVEY
- ( ) RECORD DIMENSION AS SHOWN ON UNION COUNTY SURVEY NO. 38-80
- ① REFERENCE NUMBER-SEE SURVEY DATA REFERENCE TABLE

DISTANCE SOUTHERLY ALONG THE E LINE OF THE W1/2 OF THE SE1/4 FROM THE NE CORNER THEREOF:	DISTANCE WESTERLY TO THE EXISTING FENCE FROM THE E LINE OF THE W1/2 OF THE SE1/4:
0' ±	72' (FENCE COR. S-E)
213'	48'
331'	49.3'
543'	28'
795'	12'
1020'	15'
1281'	14.5'
1384'	31.5' (FENCE COR. N-E)

ON DEC. 22, 1994, IN THE PRESENCE OF PHIL BURLING, A SURVEY TRAVERSE, INCLUDING MEASUREMENTS TO THE EXISTING FENCE, WAS RUN ALONG THE EAST LINE OF THE W1/2 OF THE SE1/4 AND ALONG THE SOUTH LINE OF THE SE1/4 BY GARY LANGLITZ, PLS 1099, AND PETER ELDER, EMPLOYEES OF ANDERSON-PERRY & ASSOC., INC.. UPON ARRIVING AT THE SE CORNER OF THE SECTION, THE GEOMETRY OF THIS TRAVERSE WAS COMPARED TO UNION COUNTY SURVEY NO. 38-80 AND FOUND TO BE UNACCEPTABLE. ON MARCH 3, 1995, MR. LANGLITZ AND JIM ARNOTT, ALSO AN EMPLOYEE OF ANDERSON-PERRY & ASSOC., CONTINUED THE TRAVERSE TO THE S1/16 CORNER OF SECTIONS 32 AND 33 AND FOUND THE TRAVERSE GEOMETRY TO AGREE ACCEPTABLY WITH SURVEY 38-80. A REVIEW OF THE FIELD NOTES FOR SURVEY 38-80 REVEALED A TRAVERSE DISTANCE TRANPOSITION WHICH CAUSED THE COMPUTED LOCATION, BUT NOT THE FIELD LOCATION, OF THE SE CORNER OF THE SECTION TO BE INCORRECT. THIS ERROR ALSO CAUSED THE E1/4 CORNER AND ALL SECTION SUBDIVISION MONUMENTS SET BY SURVEY 38-80 TO BE INCORRECT.

ON JULY 14, 1995, MR. LANGLITZ AND MR. ARNOTT CONTINUED THE SURVEY TRAVERSE EASTERLY, SOUTHERLY AND WESTERLY TO THE SOUTH 1/4 CORNER OF SEC. 32 AND FOUND AN ACCEPTABLE RELATIONSHIP BETWEEN THE TRAVERSE AND SURVEY 38-80. THE CORRECTED LOCATION OF THE E1/16 ON THE SOUTH LINE OF SEC. 32 WAS ALSO ESTABLISHED ON THIS DATE.

WITH THE EXCEPTION OF THE NE AND SE CORNERS OF THE W1/2 OF THE SE1/4 AND THE S1/16 CORNER OF SECTIONS 32 AND 33, THE CORRECTED CORNER LOCATIONS DESCRIBED HEREIN WERE ESTABLISHED WITH A STAFF COMPASS AND STEEL TAPE. THE STAFF COMPASS DECLINATION WAS ADJUSTED BY OBSERVATION OF SEVERAL OF THE LINES OF THE CURRENT TRAVERSE TO READ BEARINGS CONSISTENT WITH SURVEY 38-80. A STAFF COMPASS AND STEEL TAPE WERE EMPLOYED FOR DETERMINING THE CORRECTED CORNER POSITIONS DESCRIBED SINCE EFFORTS AT TWO LOCATIONS TO RECOVER THE POINTS (WOODEN SURVEY HUBS) OF THE 1980 SURVEY TRAVERSE WERE UNSUCCESSFUL AND, GIVEN THAT AN ERROR OF 1" IN THE DIRECTION ESTABLISHED BY THE USE OF A STAFF COMPASS RESULTS IN A POSITIONAL ERROR OF 0.4' AT THE E1/4 CORNER, THE LOCATION OF MAXIMUM CORRECTION, IT WAS DECIDED THAT THIS SURVEY EQUIPMENT AND SURVEY METHOD WOULD YIELD SUFFICIENTLY ACCURATE LOCATIONS AND BE AN EFFICIENT AND ECONOMICAL METHOD FOR CORRECTING THIS SURVEY. THE 1980 SURVEY MONUMENTS WERE LEFT IN PLACE AS DESCRIBED TO PROVIDE FOR ADDITIONAL PRESERVATION OF THE GEOMETRY AND INTEGRITY OF SURVEY 38-80.

- ① C 1/4-FD. 5/8" IRON ROD WITH PLASTIC CAP PER SURVEY 38-80, MARKED "AP1A", BEARING NORTH 3.60'. REMOVED THE PLASTIC CAP AND BURIED THE FOUND IRON ROD 0.5' REFER ALSO TO LAND CORNER MONUMENTATION RECORD FILED CONCURRENTLY WITH THIS SURVEY MAP FOR NEW CORNER ACCESSORIES.

- ② C-E 1/16-FD. 5/8" IRON ROD WITH PLASTIC CAP PER SURVEY 38-80, MARKED "AP1A", BEARING NORTH 5.17' AND EAST 10.67'. REMOVED THE PLASTIC CAP AND BURIED THE FOUND IRON ROD 6". CORRECTED MONUMENT LOCATION IS 5' SOUTH OF AN EXISTING E-W FENCE AND 72' EAST OF A CORNER OF FENCES S-E.

- ⑤ S 1/4-FD. 2" GALVANIZED IRON PIPE WITH BRASS CAP, FIRMLY SET, AND MARKED AS DESCRIBED ON SURVEY 38-80, WITH TWO BEARING TREES, ALIVE AND IN GOOD CONDITION, AS DESCRIBED ON SURVEY 38-80.

- ⑥ E 1/16-MONUMENT SET BY SURVEY 38-80 NOT FOUND. SET NEW MONUMENT AS SHOWN.
- ⑦ SE CORNER-SEC. 32-MONUMENT PER SURVEY 38-80 WAS NOT FOUND. SET 5/8" IRON ROD (CONCRETE REINFORCING ROD) BY REFERENCE TO THE EXISTING BEARING TREES ESTABLISHED BY SURVEY 38-80, WITH YELLOW PLASTIC CAP ATTACHED, MARKED "AP1A", BURIED 6" IN THE MIDDLE OF A GATE IN AN E-W FENCE AND IN A DIRT ROADWAY. REFER TO LAND CORNER MONUMENTATION RECORD FILED CONCURRENTLY WITH THIS SURVEY MAP FOR ADDITIONAL INFORMATION.
