**BAGETT-GRIFFITH & ASSOCIATES**  
LaGrande, Oregon  
Map of Survey  
The South 100 feet of  
Lot 6, Block D,  
The Town of the Cove  
UNION COUNTY, OREGON

SURVEYED FOR	David Cline	
SURVEYED BY	R. G. R.	5-94
Scale: 1"=100'	Drawn by: R. G. R.	5-94

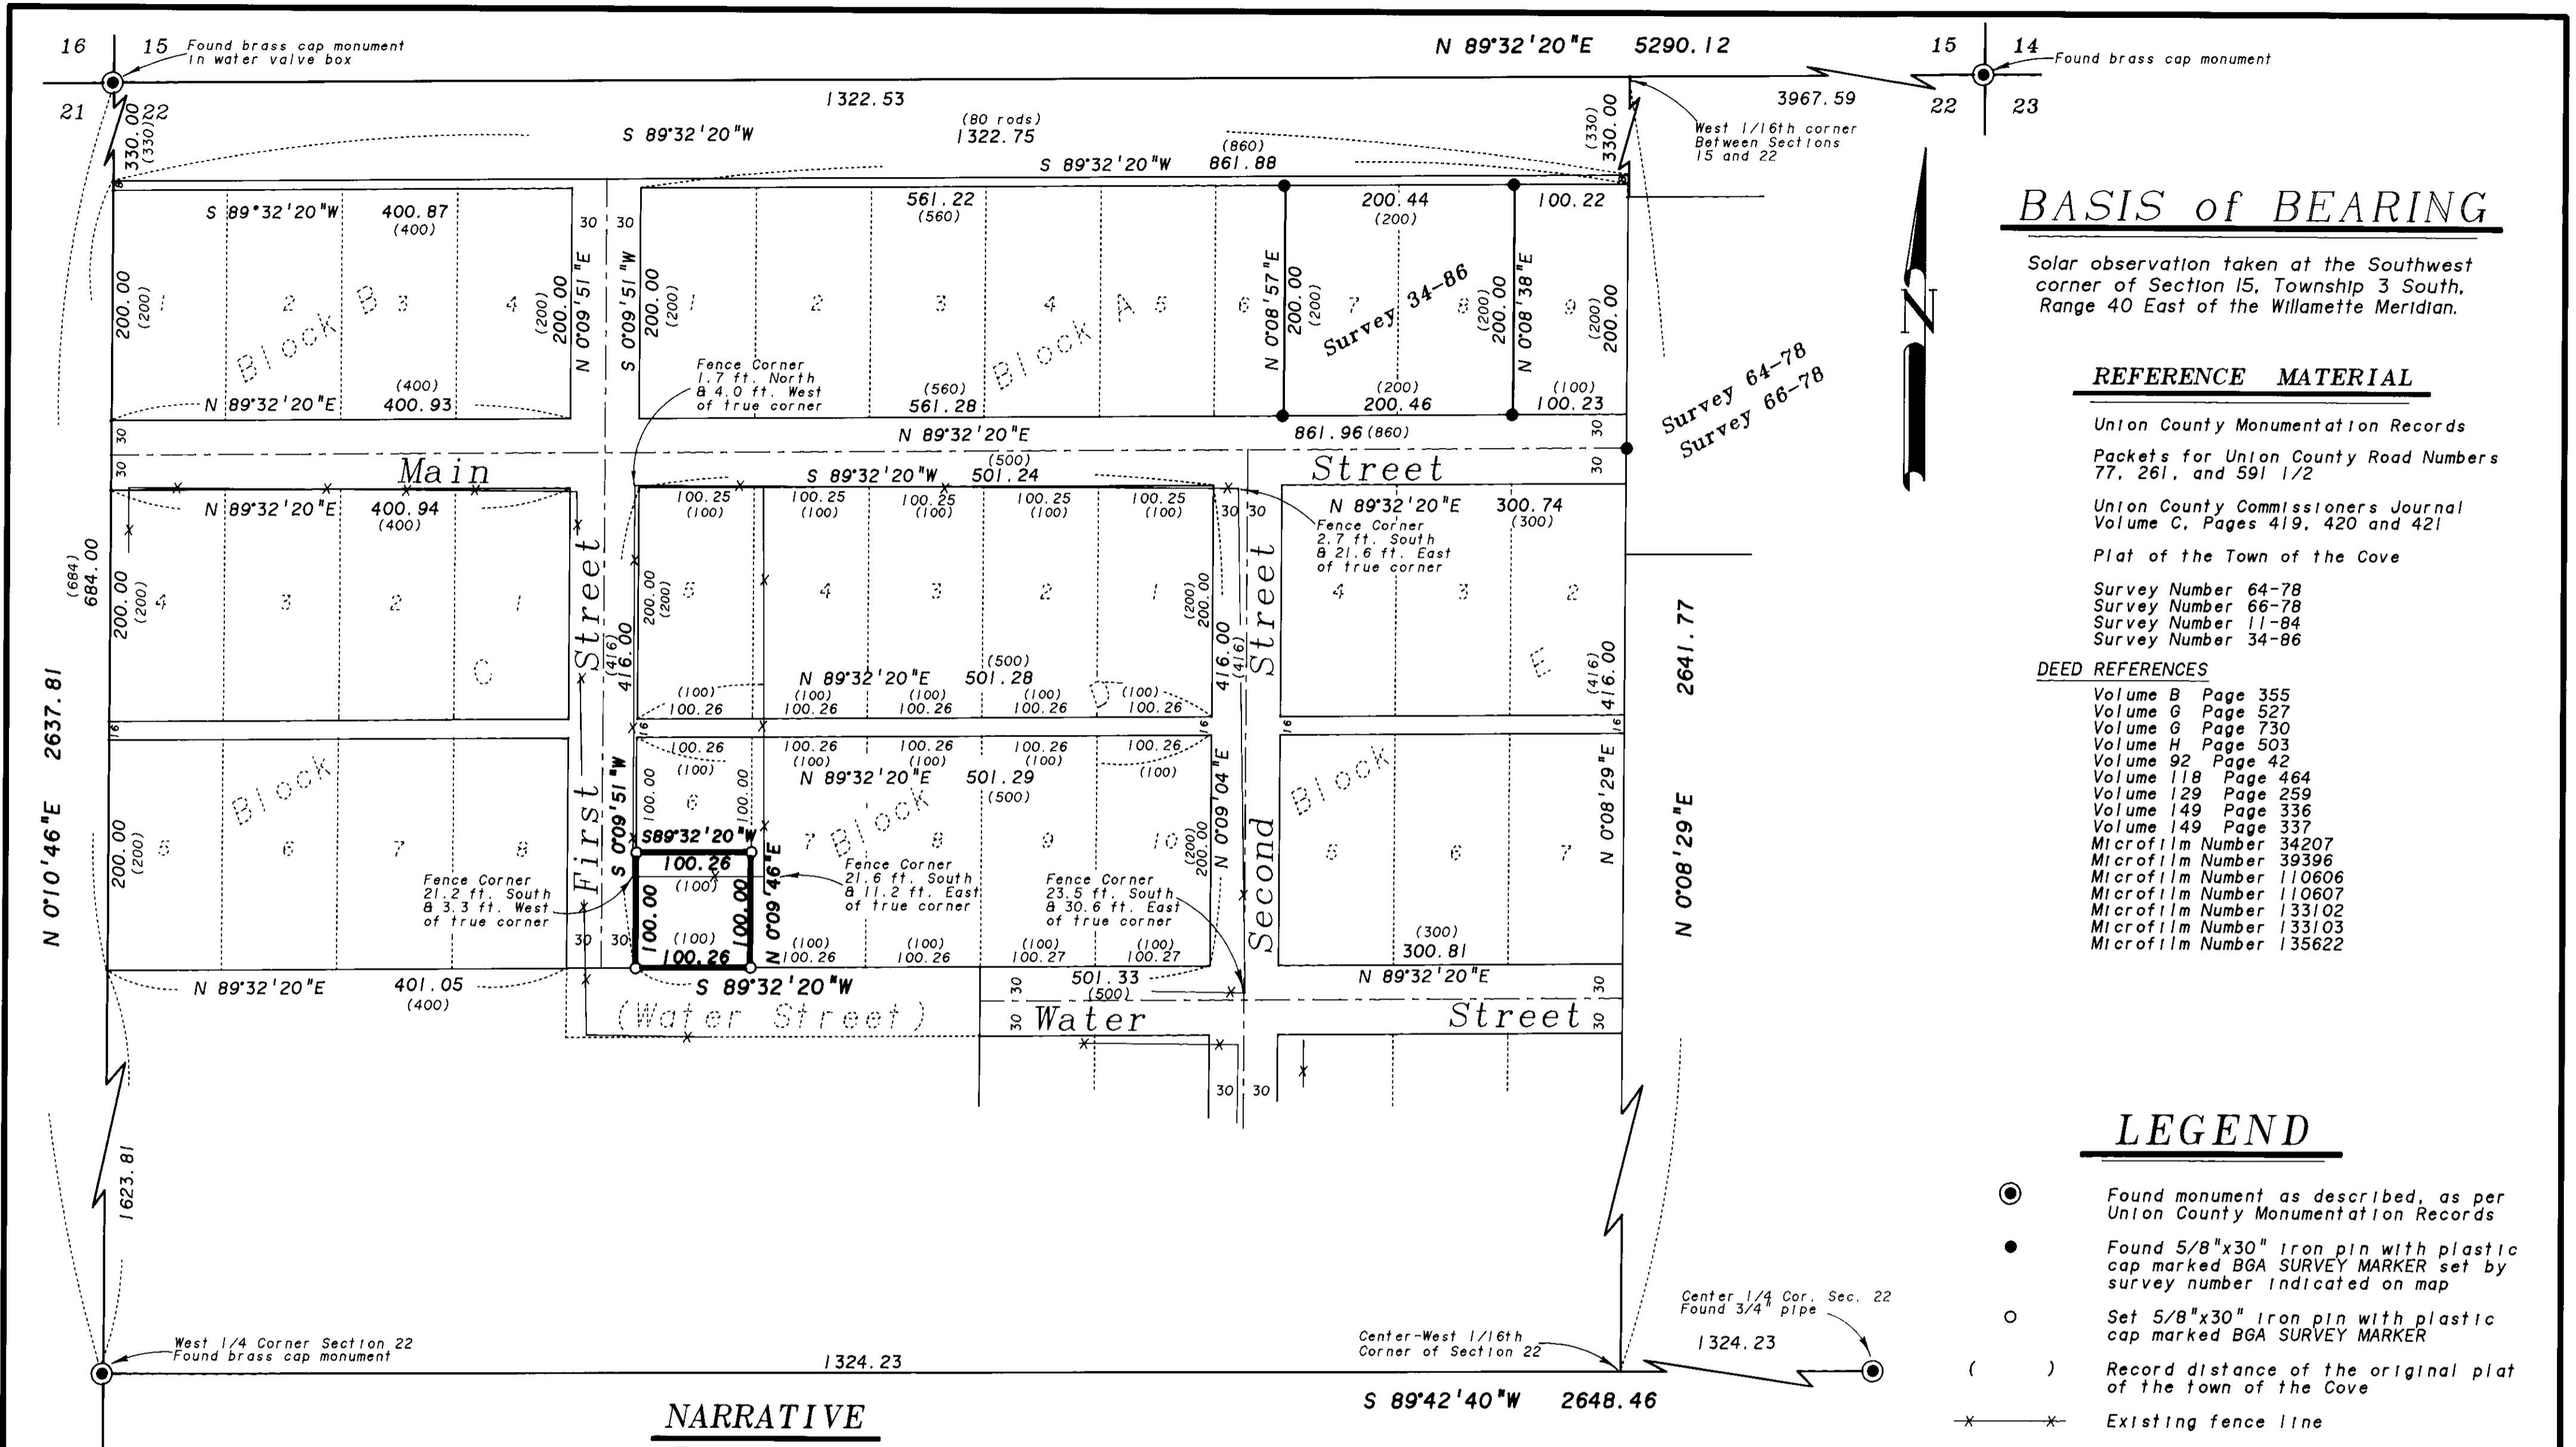
Solar observation taken at the Southwest corner of Section 15, Township 3 South, Range 40 East of the Willamette Meridian.

This survey was done at the request of David Cline. This survey is based on survey number 11-84, which placed the exterior of the plat of the Town of the Cove. The result of that survey placed the North-South dimensions of the plat at record distance, with the East-West dimensions being slightly excessive of the record call as shown. I find with this survey that the existing fences are relatively harmonious along the East line of First Street and the South line of Main Street as shown. However, the further East and South into the subdivision, the lines of occupancy become more skewed and offset. As discussed in the narrative of survey 11-84, there was some conflict with the county road in the vicinity of Second Street of the plat. This could explain why the fences do not fit the platted lots in that area. The Cline property itself is a remnant, with the North 100 feet of Lot 6 being transferred by deed microfilm number 133102. Since there was no excess or deficiency in the North-South dimension that leaves the parcel as being 100 feet North and South. I find an existing fence line to encroach onto the Northerly portion of the Cline parcel as shown. I show the existing fences in the area for informational purposes. I find that the placement of the plat dimensions does not allow for Water Street along the South line of Lots 6, 7 and 8 of Block D. This is also shown on surveys 11-84 and 34-86. The road is constructed and does exist on the ground. The plat does show Water Street to exist across this area. It does have a prescriptive right. No deed research was done to see if the street was later transferred by deed. I find no other unusual conditions on this survey.
